*EAST BAY MUNICIPAL UTILITY DISTRICT*

# **Asbestos Cement Pipe Study**

## Phase 1 Asbestos Cement Pipe Corrosion Study

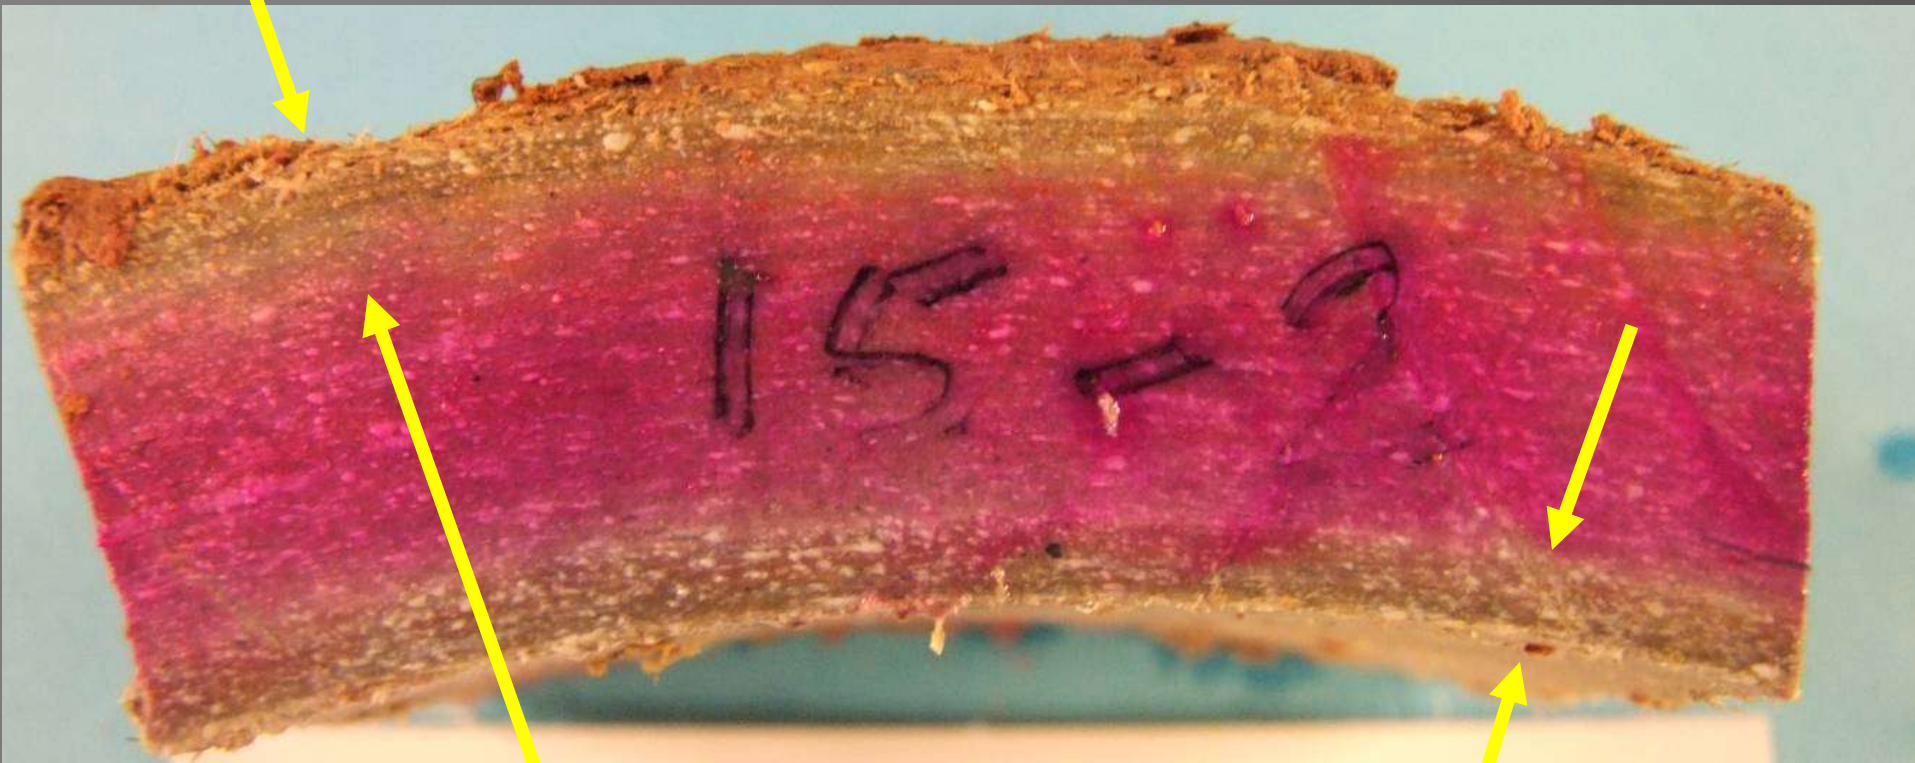
# AC Pipe Corrosion Measurements

Outer Diameter (OD) Thickness

Inner Diameter (ID) Thickness

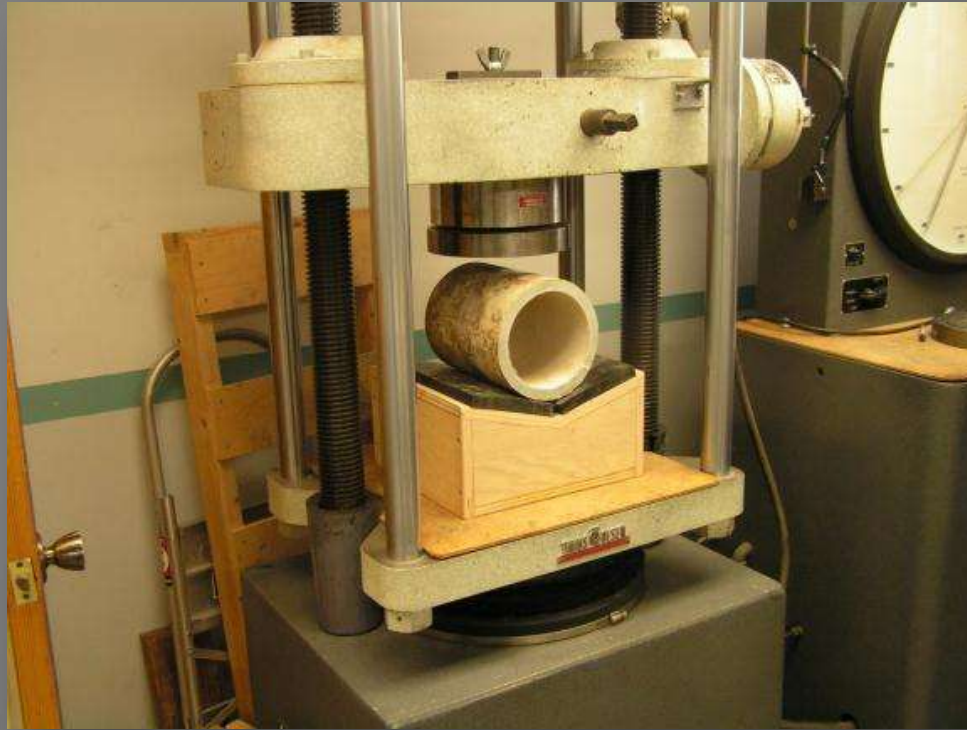
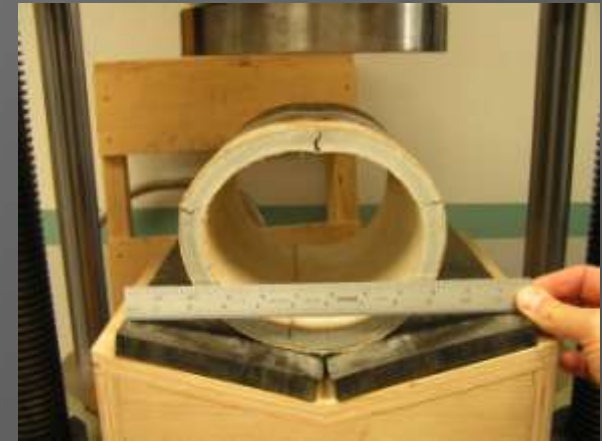
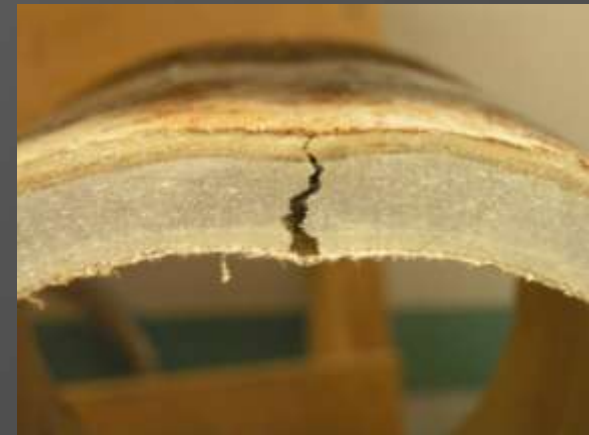
# Crush Strength Test

Crush strength tests conducted on the pipe samples indicated that all of the samples met the requirement of as-manufactured (new) pipe for Class 150 pipe
