Replacement of a Large Diameter Transmission Pipeline Using Slip Lining

Peter J. Jauch, P.E.
Ryan C. Pearson, P.E.

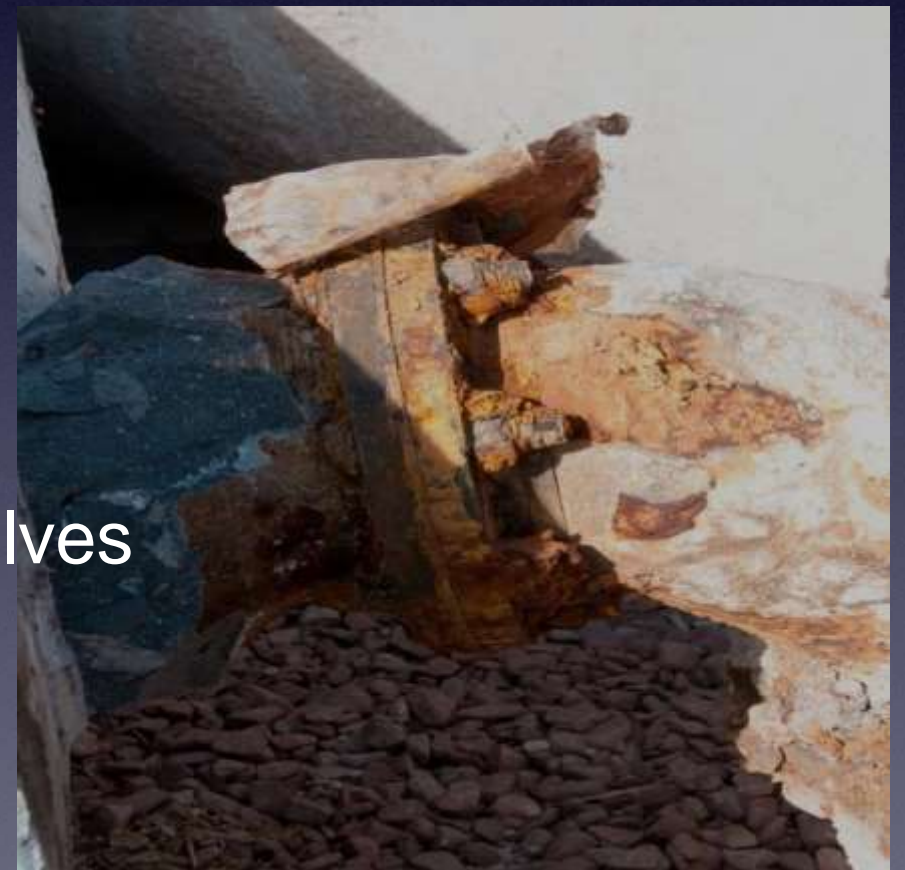
- Potential leaks under I-215 discovered
- Existing 36-inch diameter MLCP pipe
- Discovered by District Asset Management
- Discovered using Echo Logics equipment
- Section immediately isolated via existing valves
- Inspected via CCTV

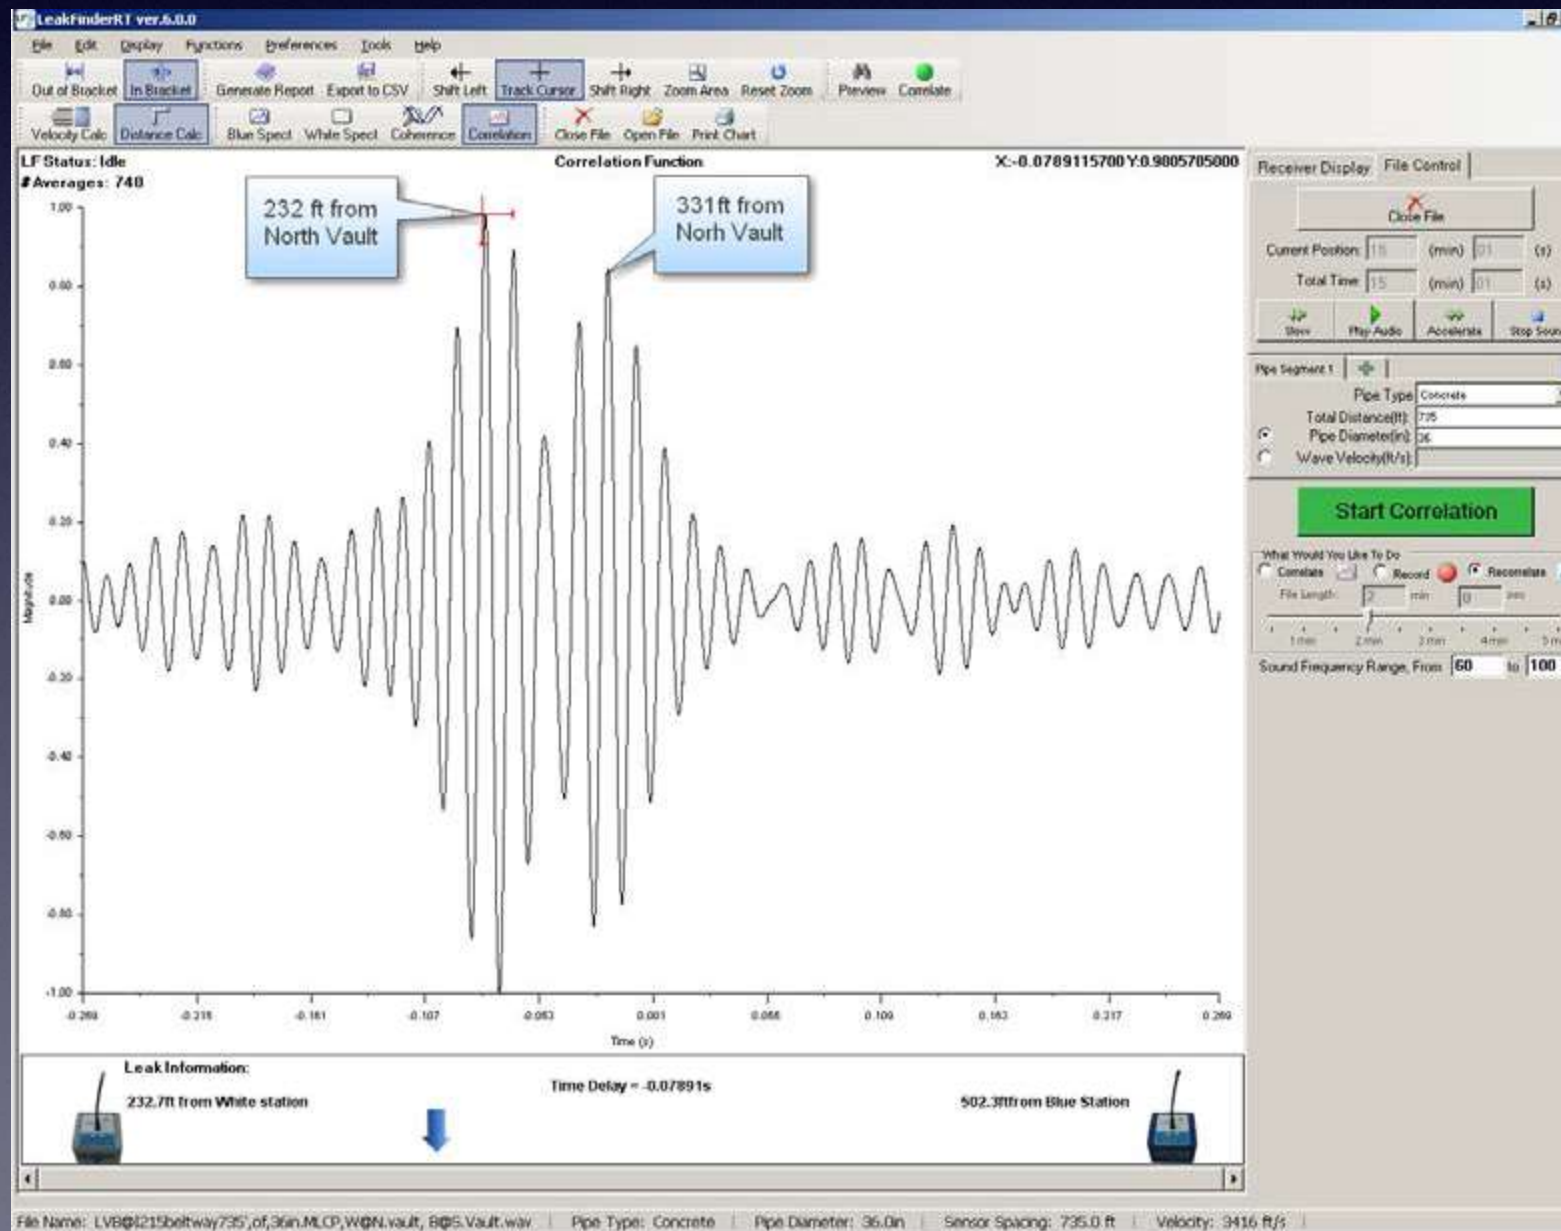
- Echo Logics Attenuation Data

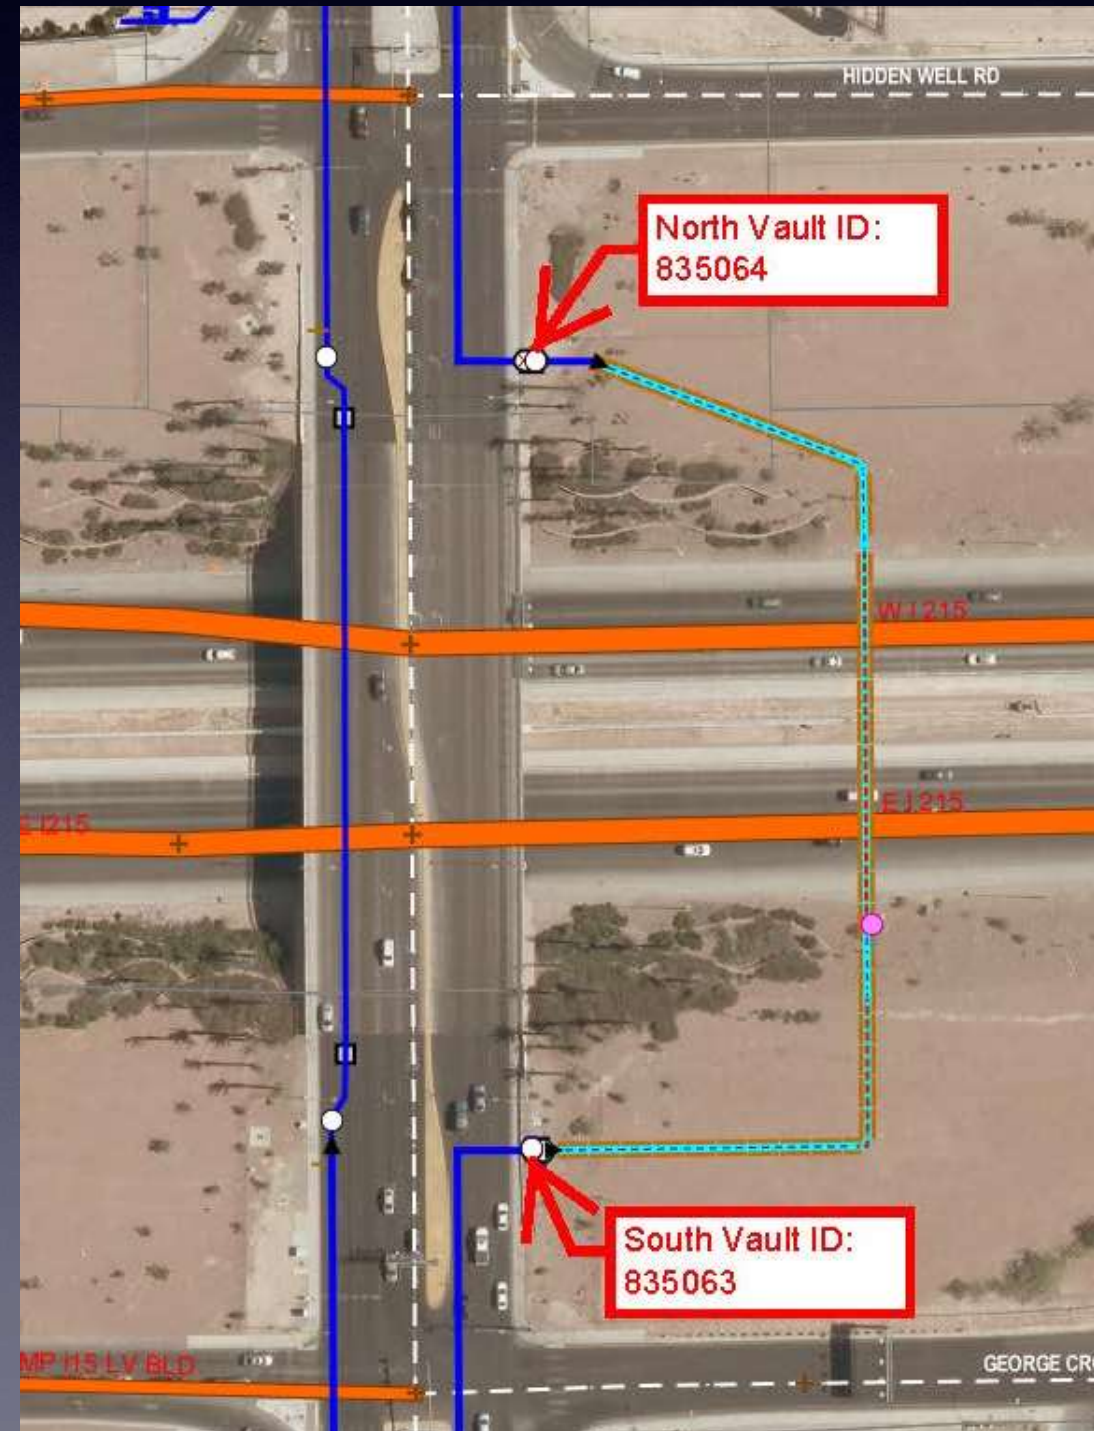
- Section immediately isolated via existing valves
- Inspected via CCTV

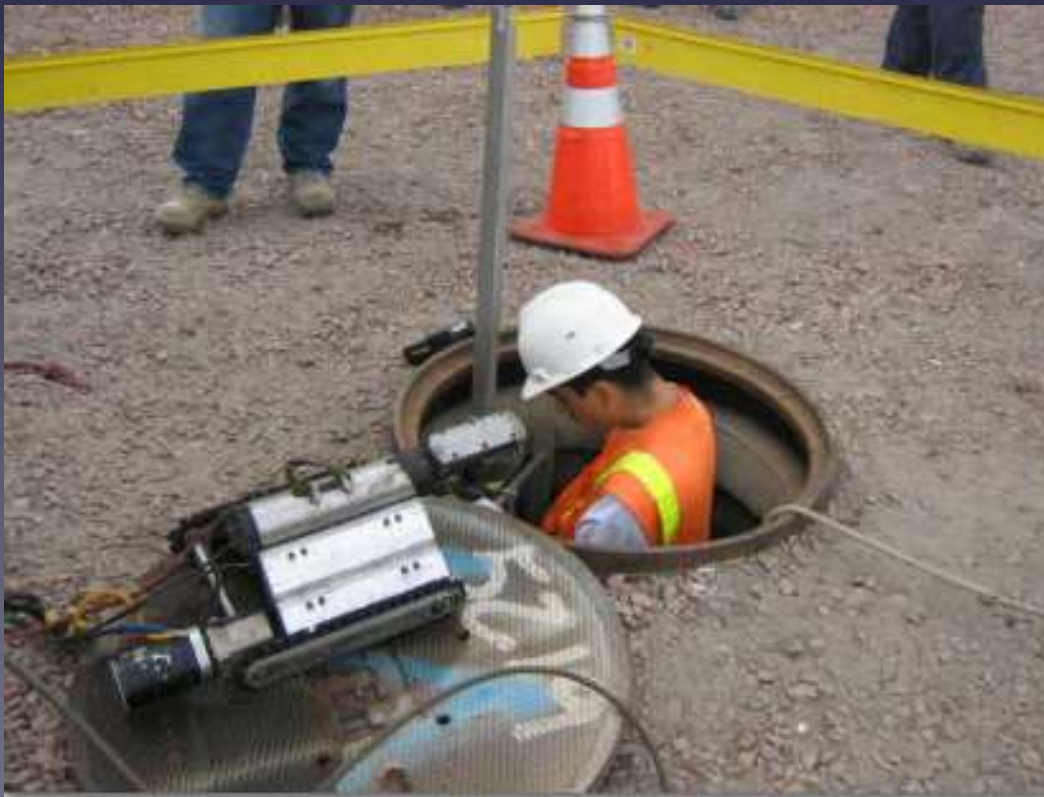
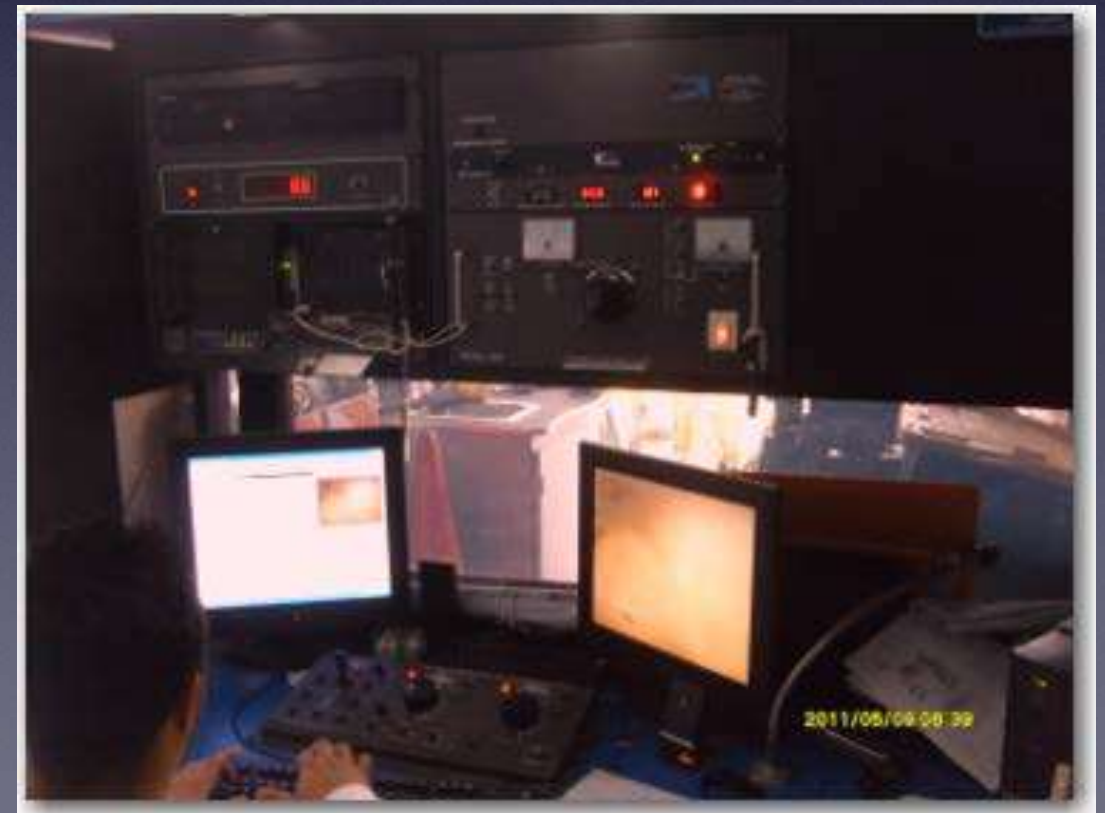
- Closed circuit TV was used to attempt to identify source of leaks.
- May be able to identify leaks and do spot repairs on the line.

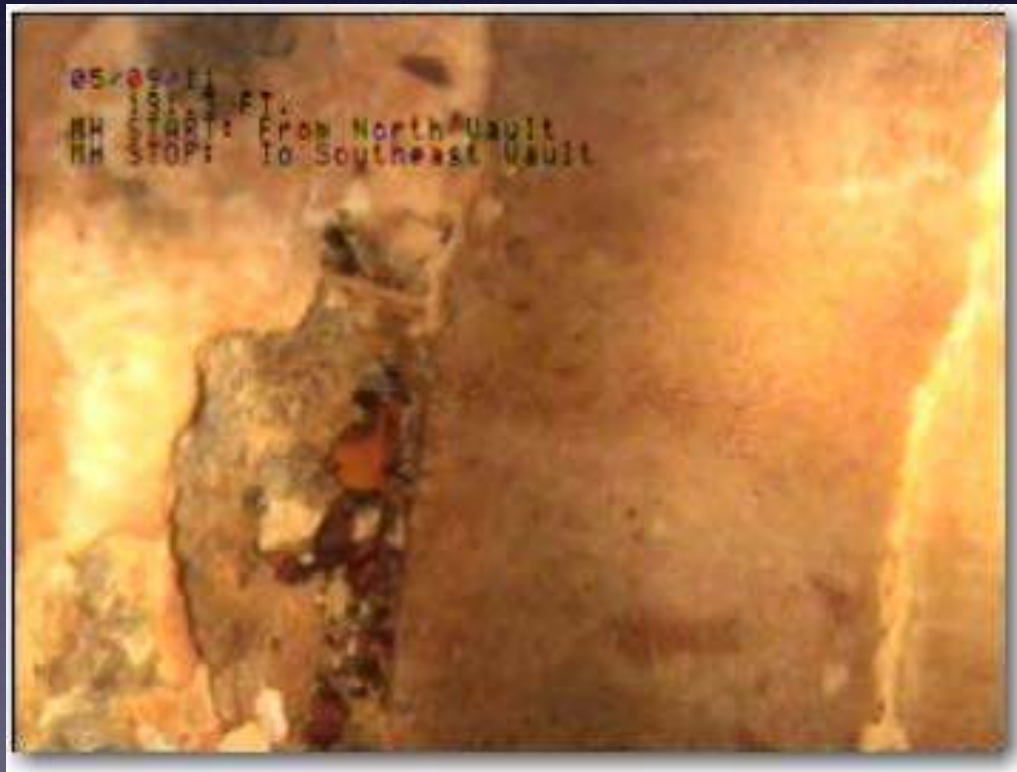
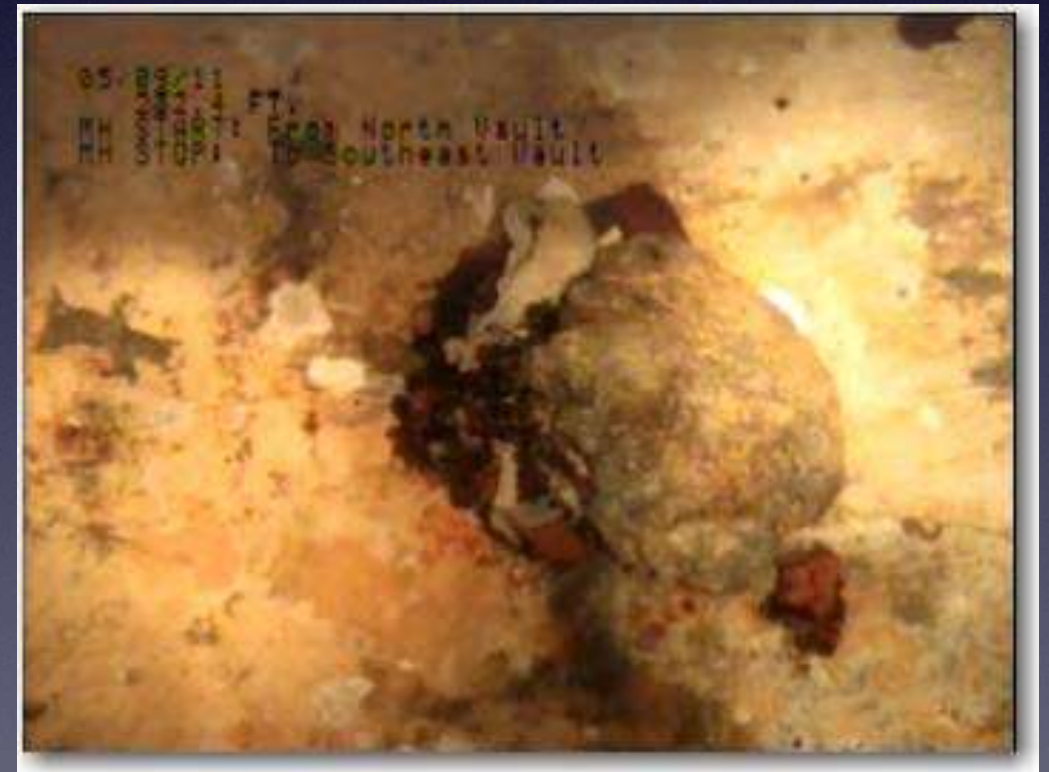
- Video indicated potential corrosion issues

- Local Repair
 - Numerous areas of corrosion were determined
 - Unclear which, if any area was cause of leak
- New MLCP Installation
 - Requires new casing installation
- Cured In-Place Pipe
 - No previous installation with Class IV liner at this diameter of potable water pipeline

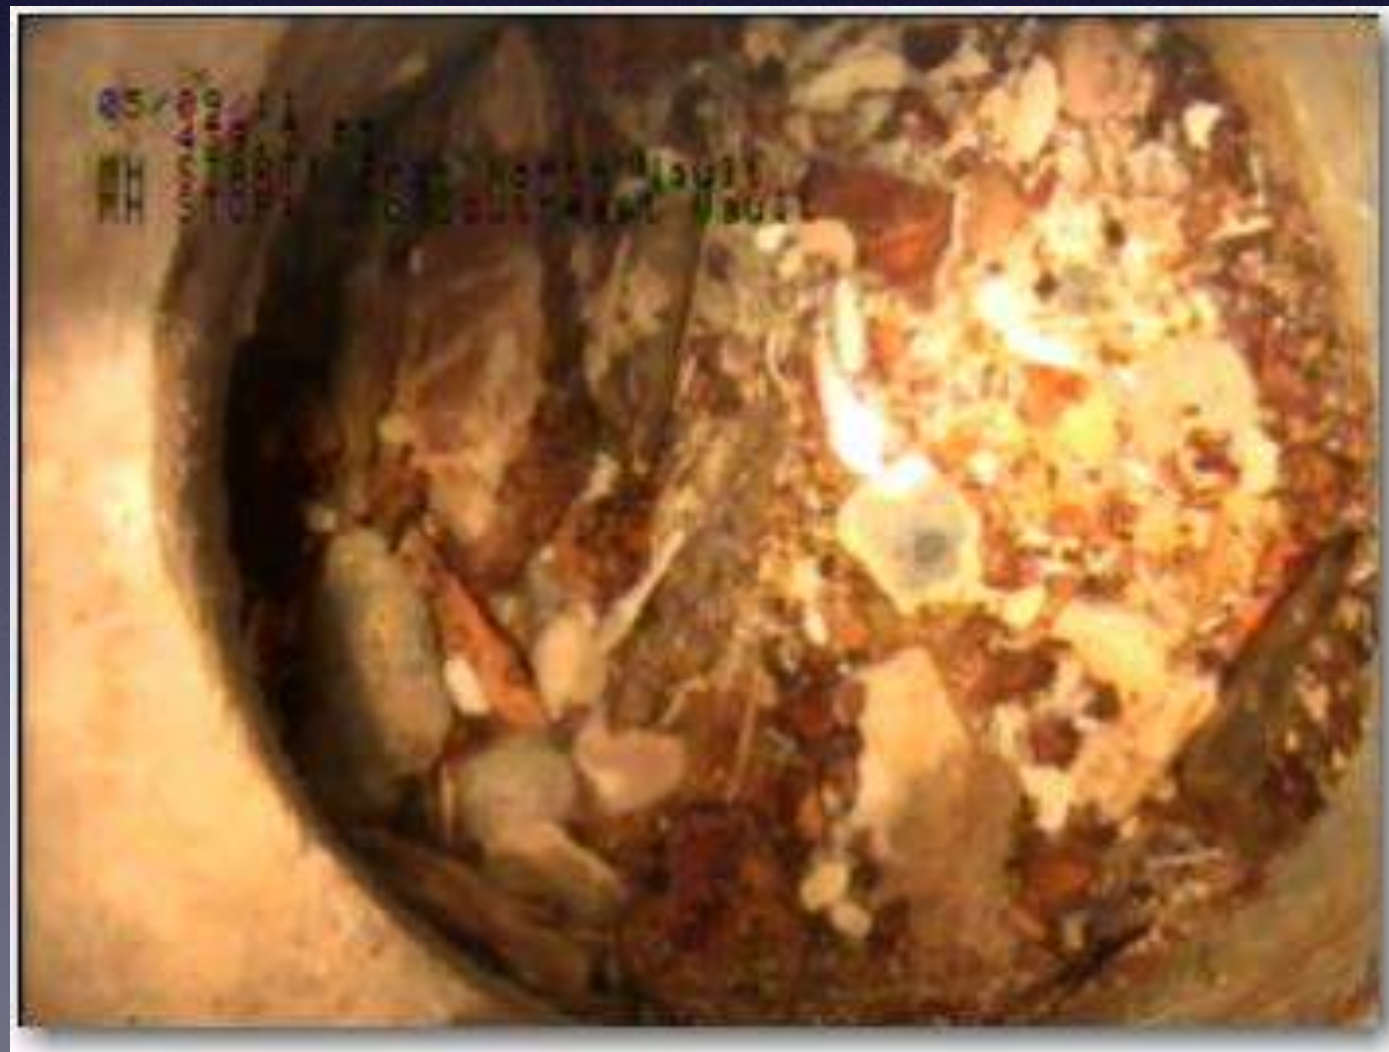
- Video indicated blocked blow-off

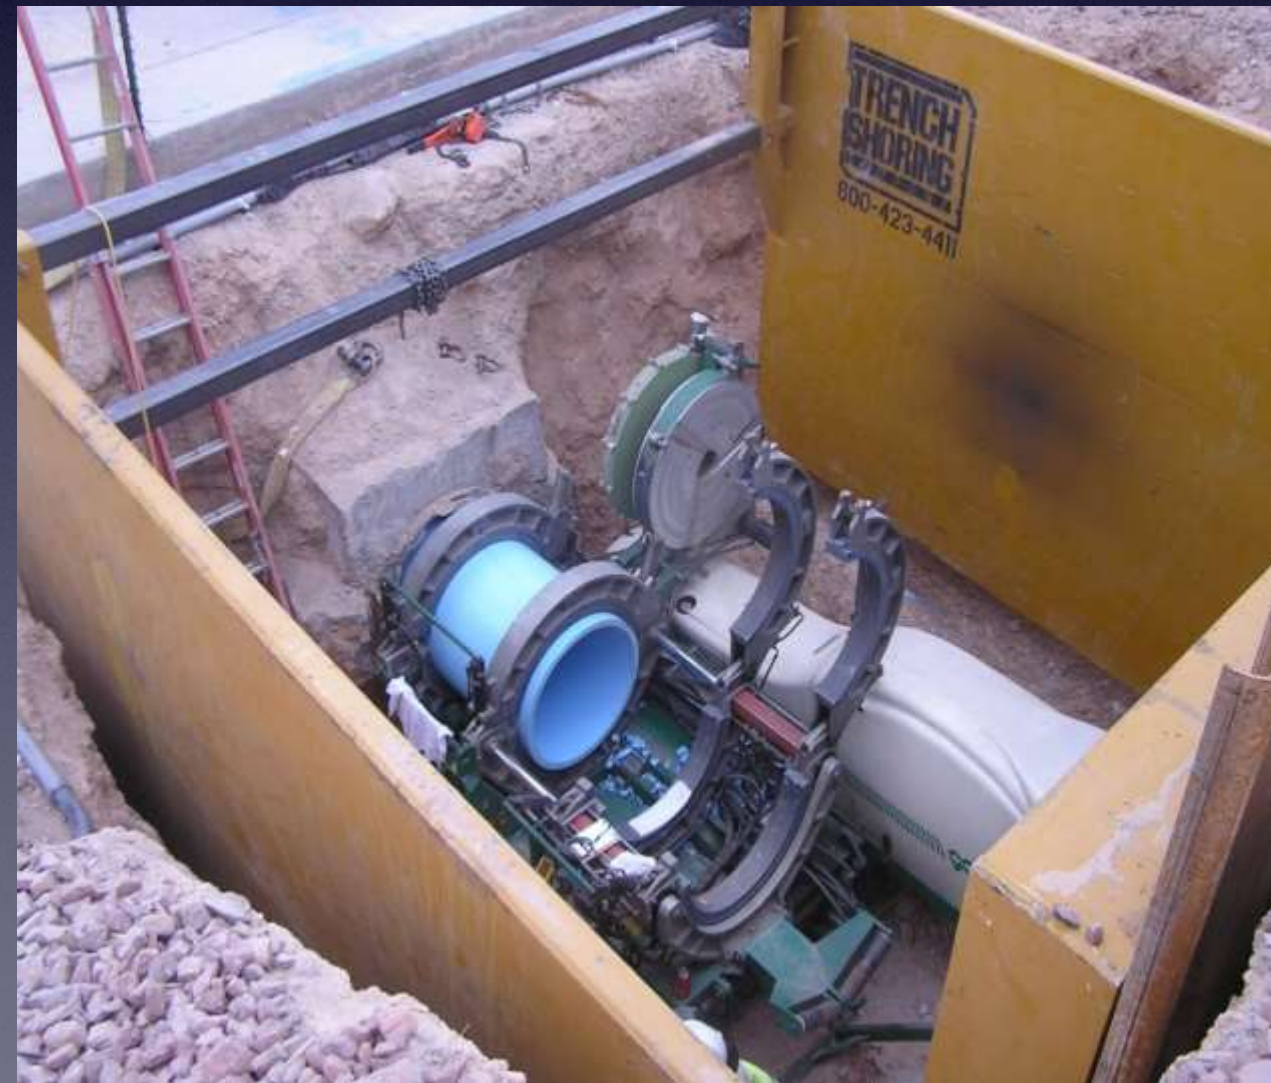
- In Pit vs. Above-Grade Fusing
 - Length of Pipe Segments Based on Site Geometry
 - 10-Foot Segments Fused in Pit
 - 40-Foot Segments Fused Above Grade

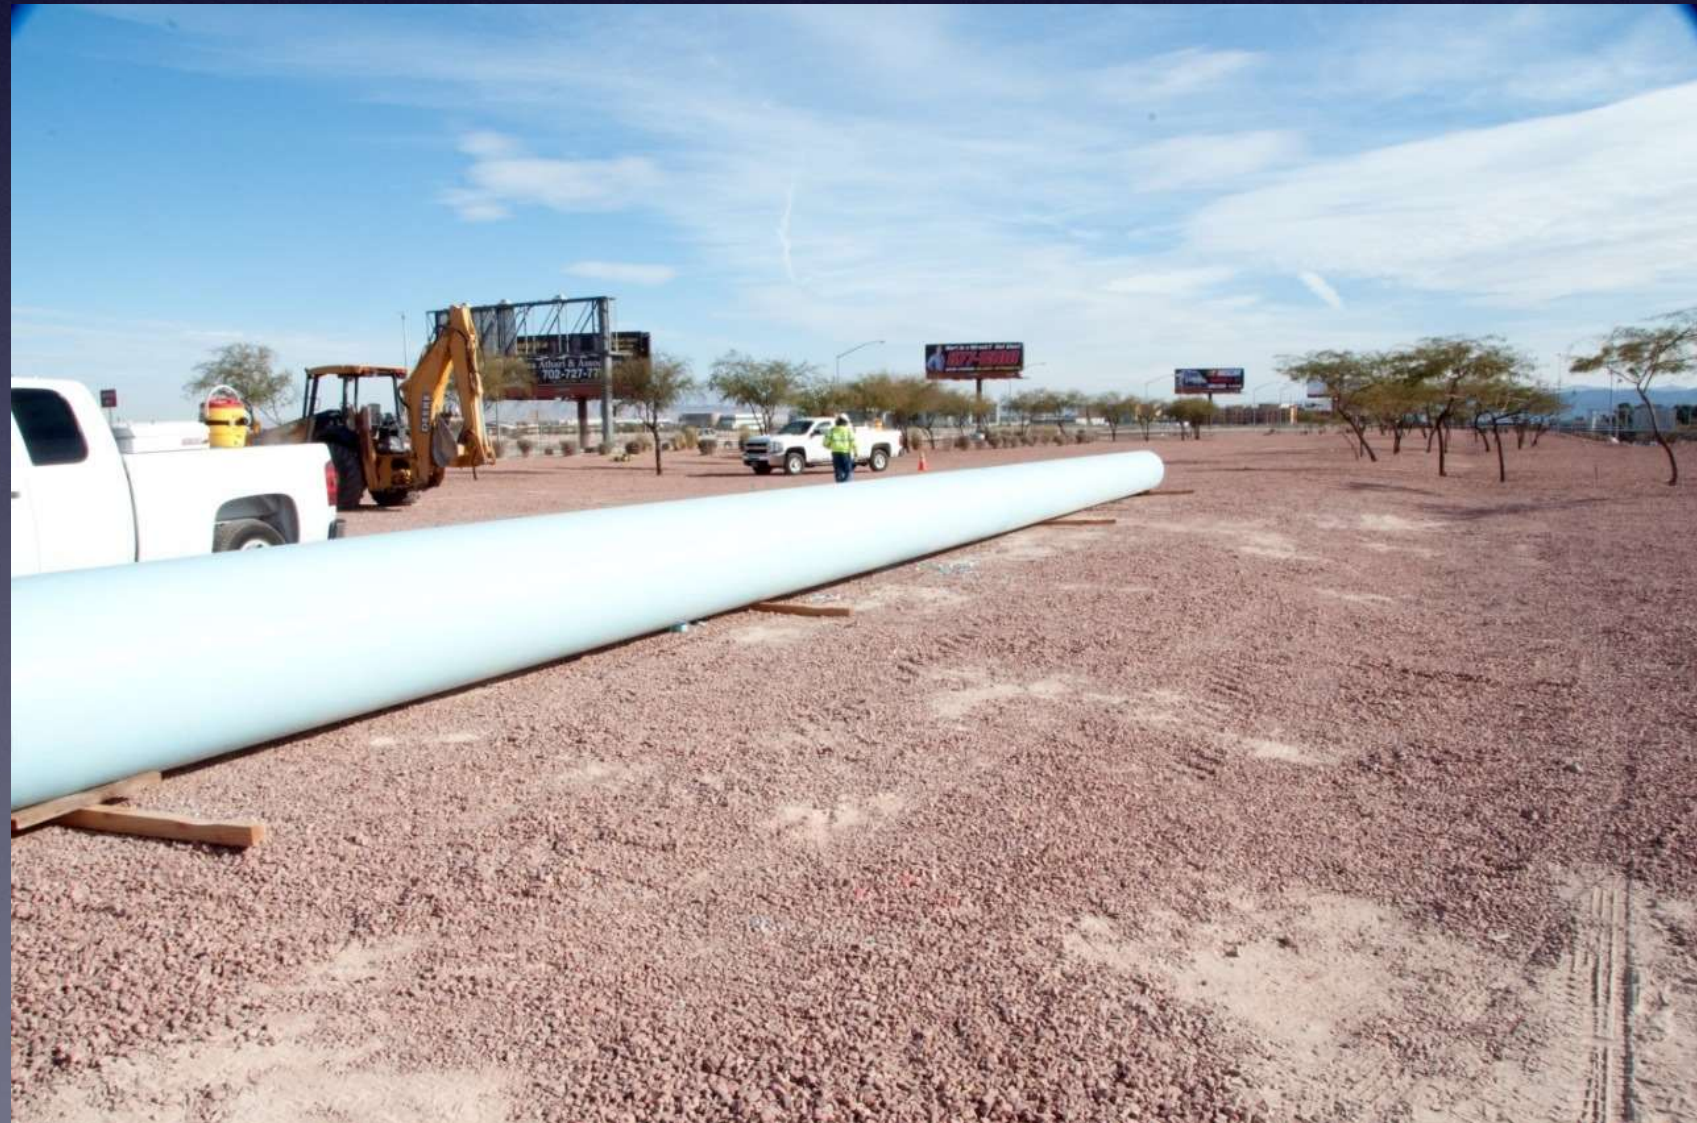
- In Pit vs. Above-Grade Fusing
 - 40-Foot Lengths of Pipe

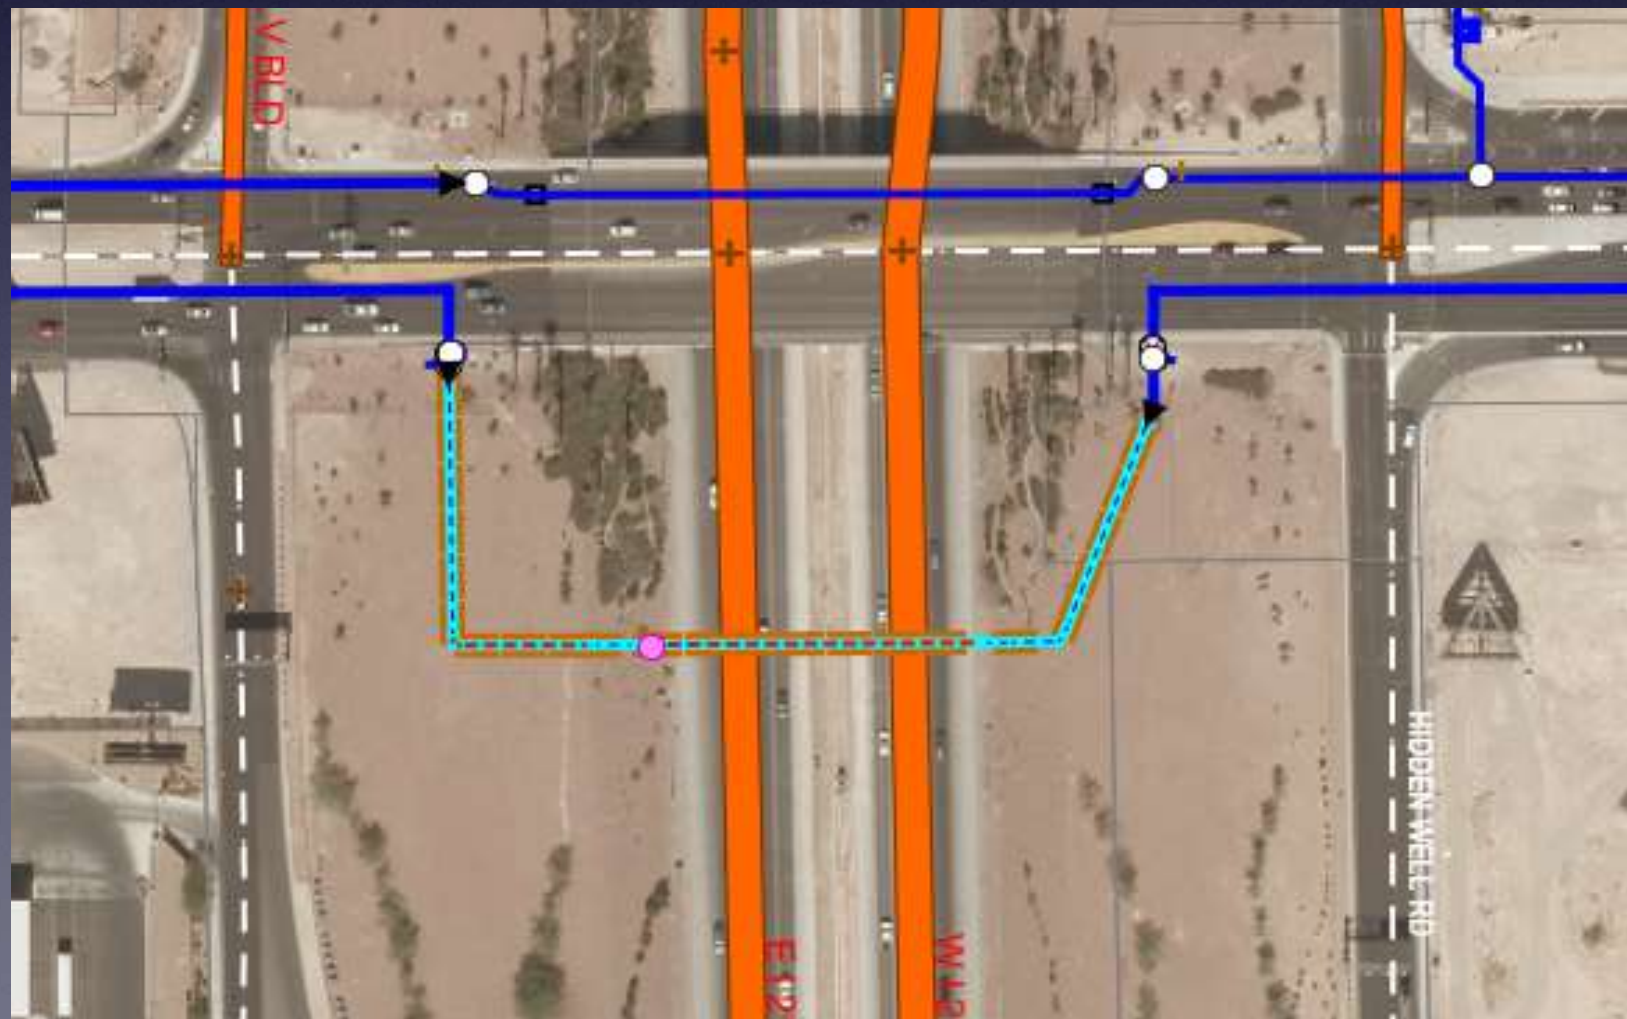
- Site Geometry and Pipe Profile
 - Numerous bends that could not be sliplined
 - Require insertion pits

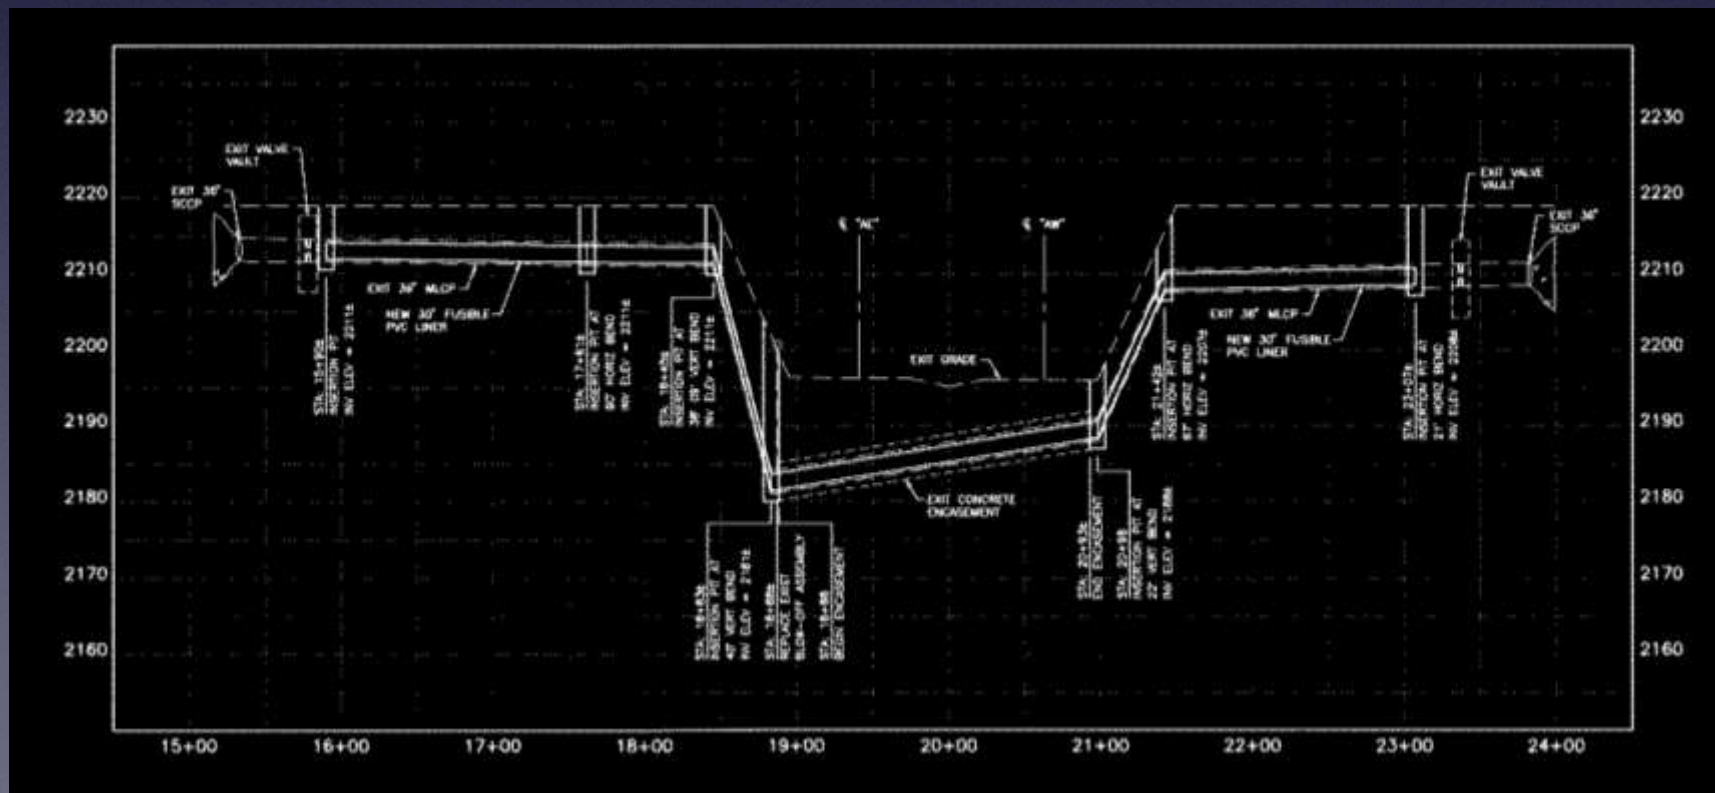
- Site Geometry and Pipe Profile
 - Numerous angle points that could not be sliplined
 - Require insertion pits

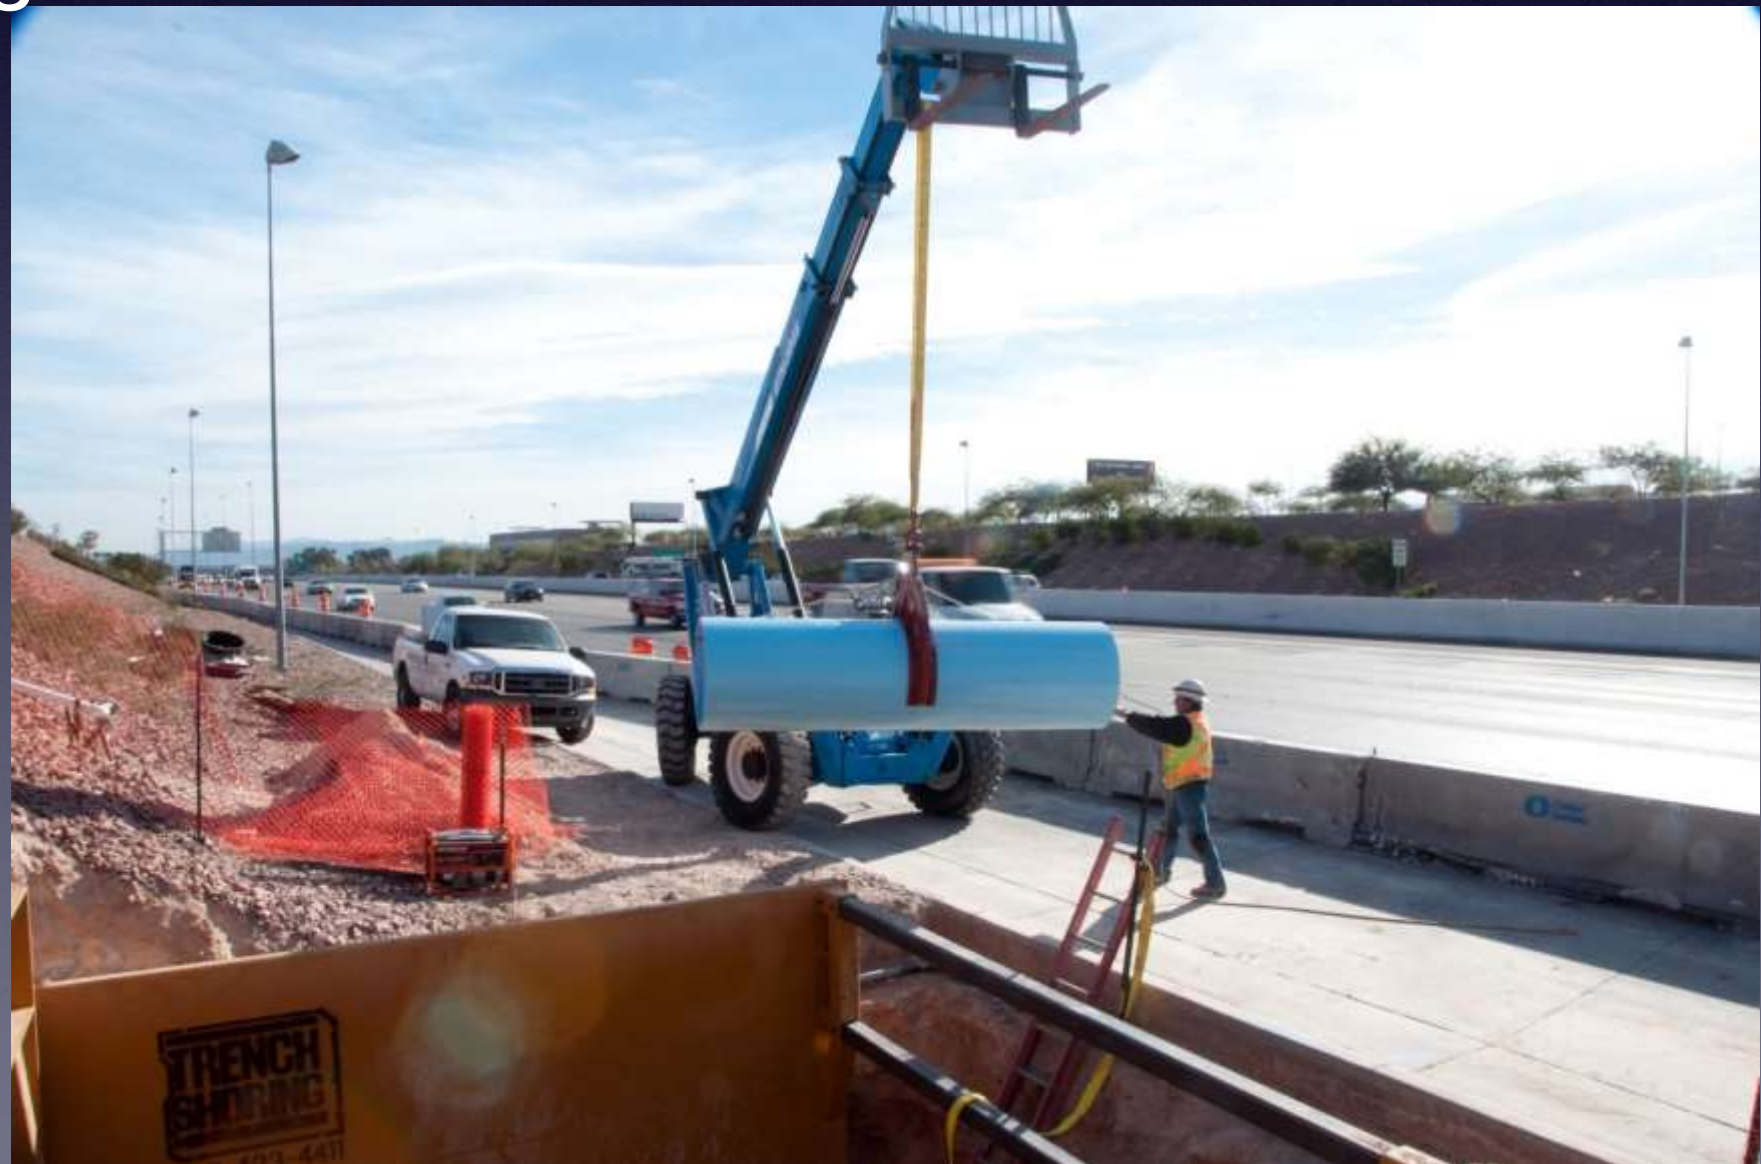
- Proximity of I-215
- Steep Side Slopes
