# **Multiple Pipeline Tools Used to Rehab/Replace 7-mile Pressure AC Main**

**CA NV AWWA, Pipeline Rehabilitation Committee**

**October 1, 2013**

**By Tim Williams and Tracie Mueller,  
Kennedy/Jenks Consultants**

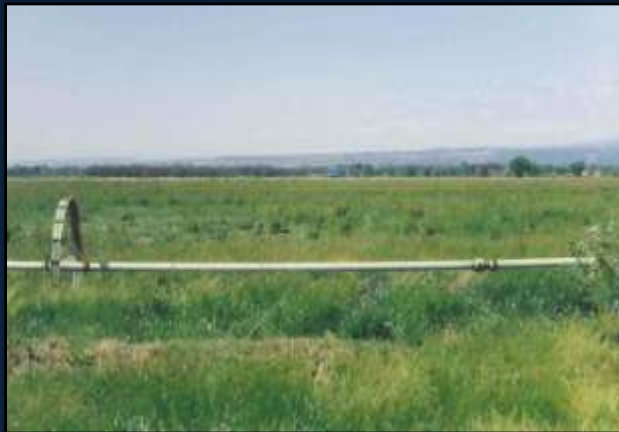
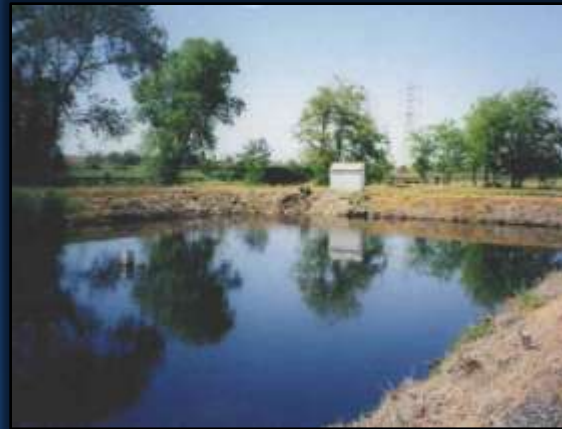
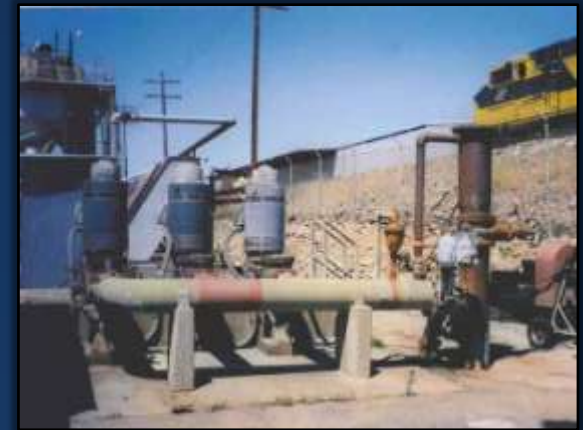
- 7-mile AC Pipeline – Industrial Wastewater Force Main constructed in 1976
- Conveys tomato (1976 to 1999) and fruit canning (2000 to present) waste from Factory to Industrial Waste Treatment and Land Application site

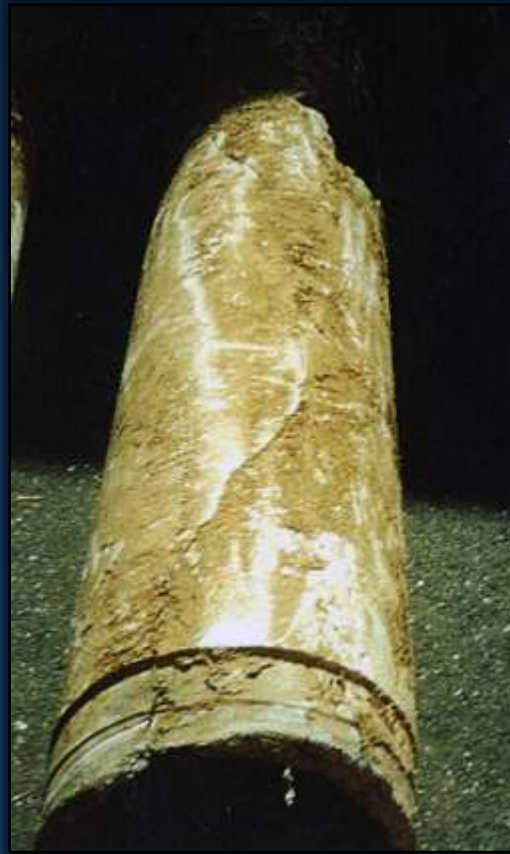
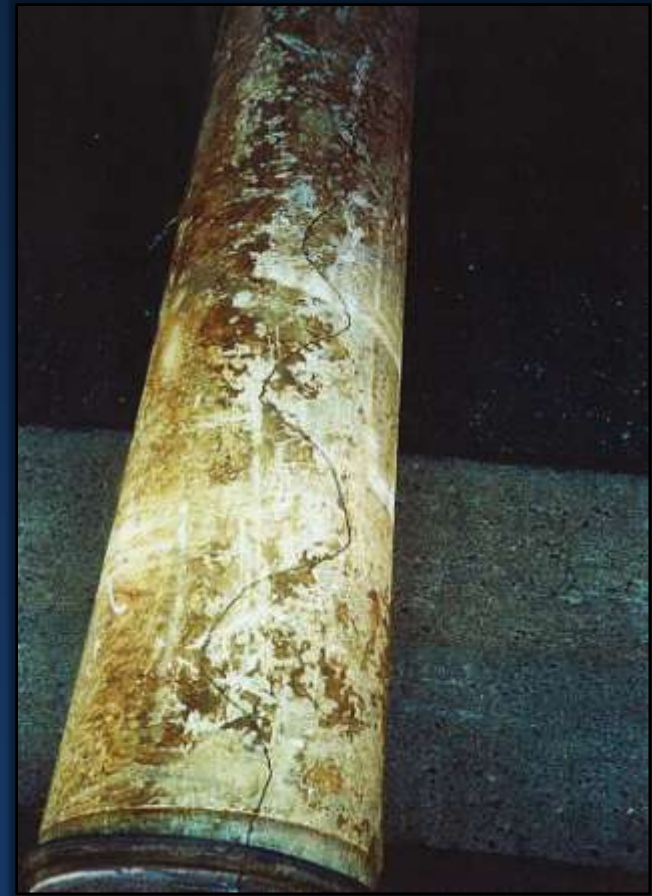
# Pipeline Break History

- Over 10 breaks, varying from 1 to 3 per year for over a decade

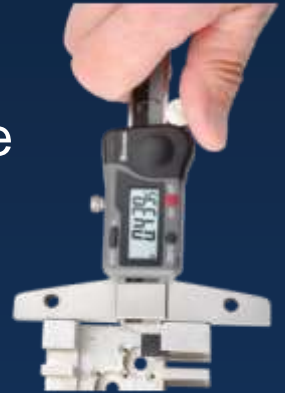
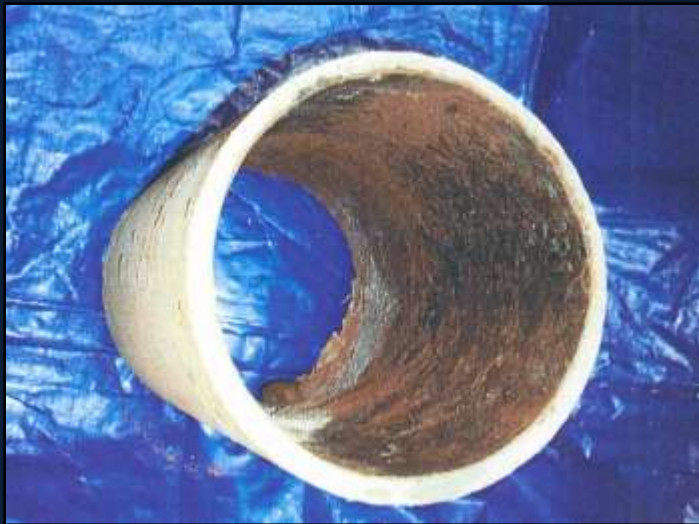
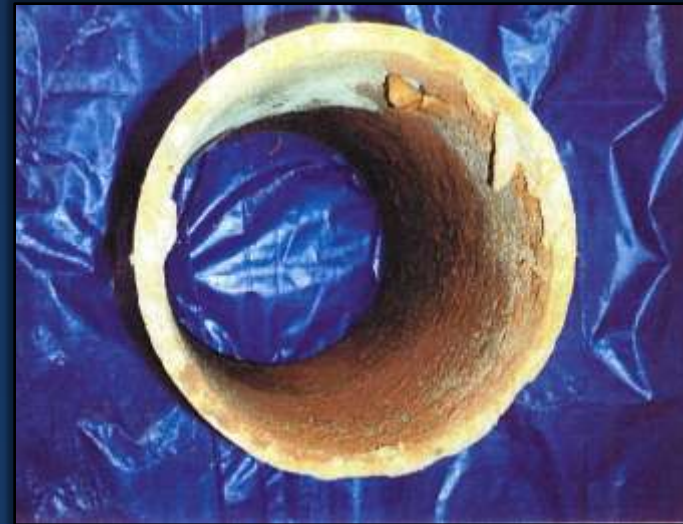
# Methods to Investigate Pipe Breaks

- Photograph and physically review specimens
- Measured by caliper micrometer and depth of softness of the surface by Starrett® pitting gauge

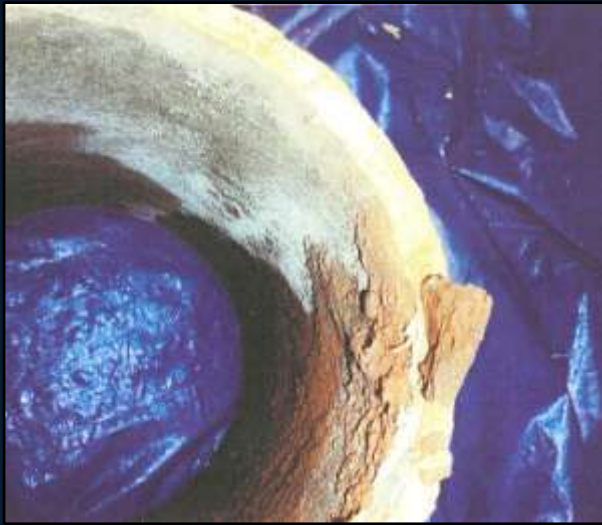
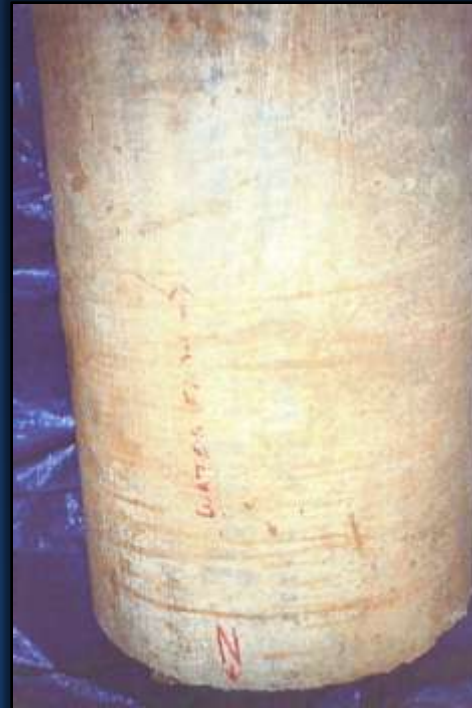
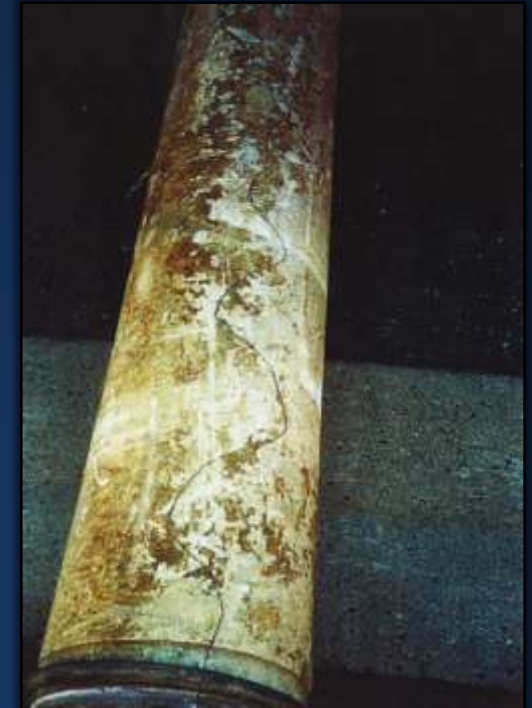
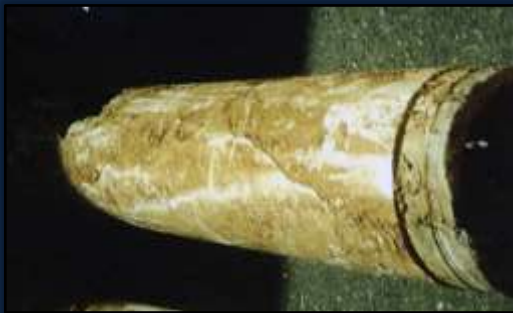
# Pipe Breaks

- Circumferential breaks – flexural displacement load
- Longitudinal breaks – internal pressure and bursting failure

- Construction methods – poor backfill and bedding causing settlement and circumferential cracks
- Increased surge effects with 2<sup>nd</sup> pump activation causing longitudinal cracks
- Deterioration of pipe wall thickness – leaching of calcium from pipe, soft fibrous profile
- Investigation and estimated useful life basis:
  - Allow up to half the wall thickness in Class 150 before critical to replace pipe
  - Reduces safety factor from 4:1 to 2:1 bursting resistance

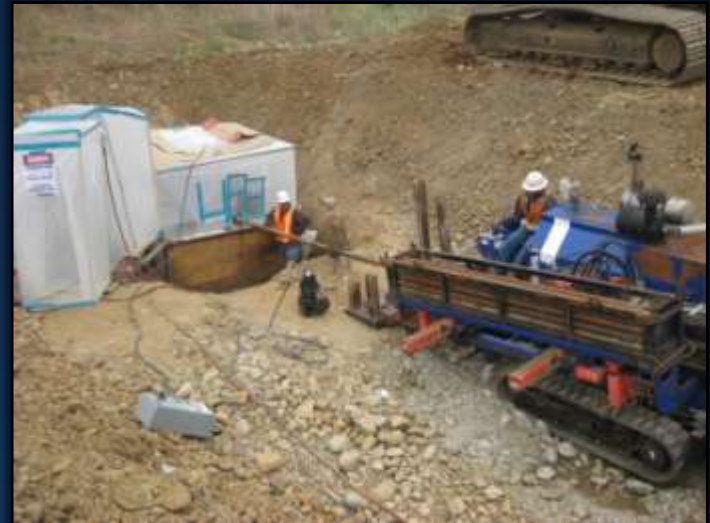
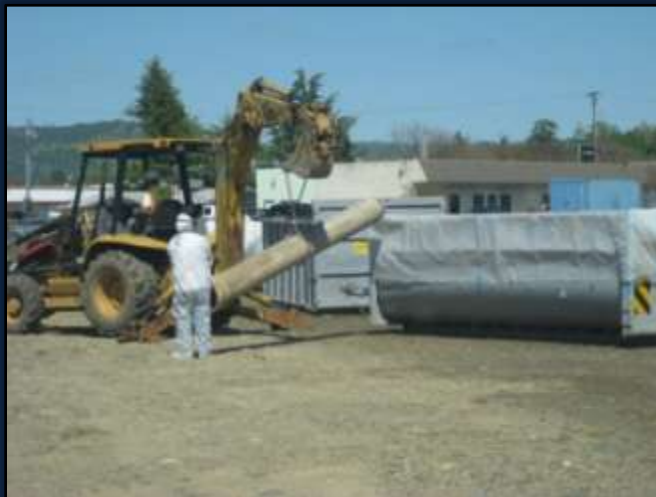
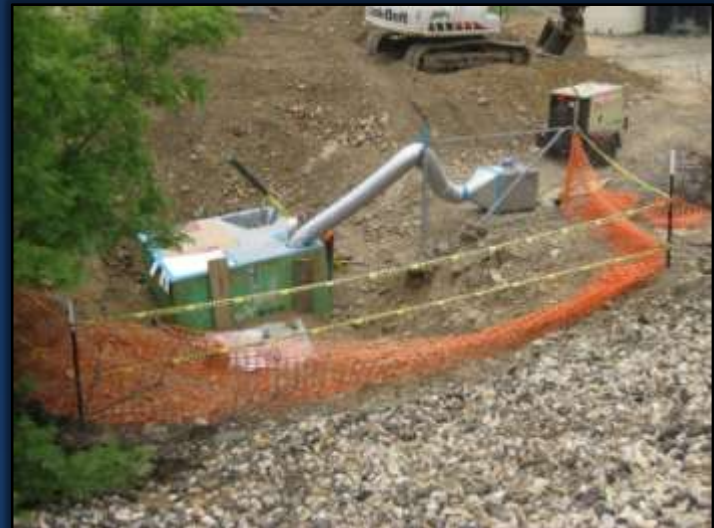
# Phase 1 – Lessons Learned

- Original plan pull pipe from casings
  - Check both ends of each casing
- CO - Drilled out AC pipe in (E) casing for UPRR
  - AC haz mat trained personnel on-site
  - Special monitoring for AC friables
  - Enclosure and capture air
  - Capture and dispose of drilling muds

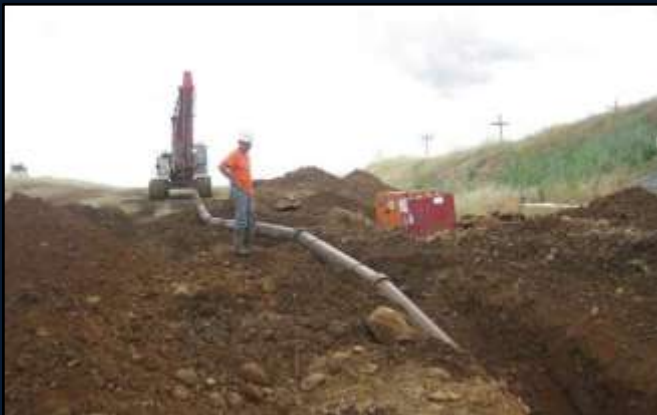
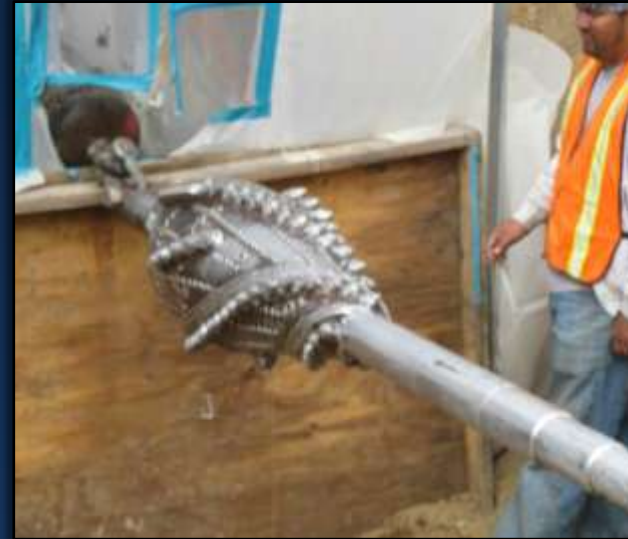
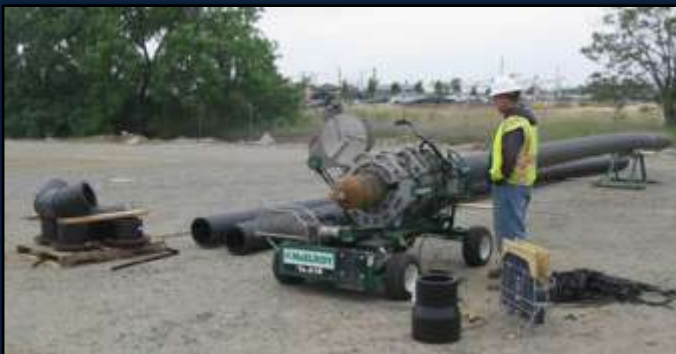
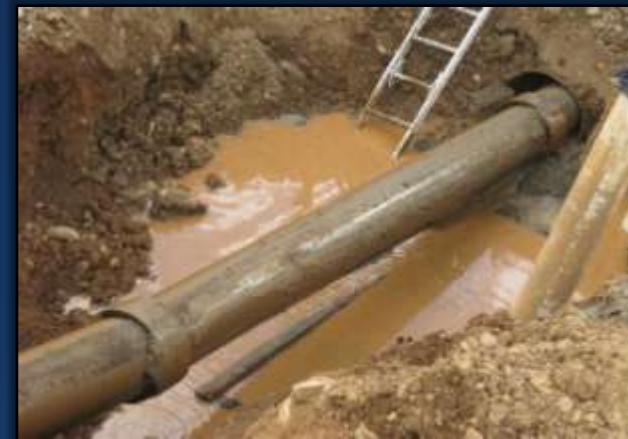
# Phase 1 – Lessons Learned

- Use an experienced trenchless contractor
- CCTV & pressure test pipe after installation
- Avoid grouting within casings if possible

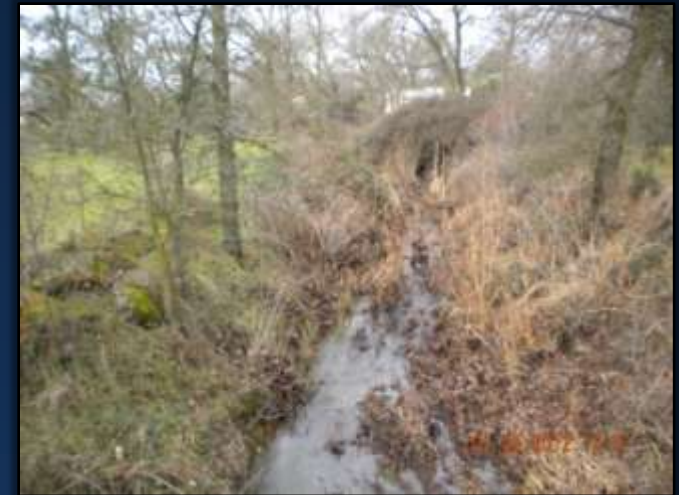
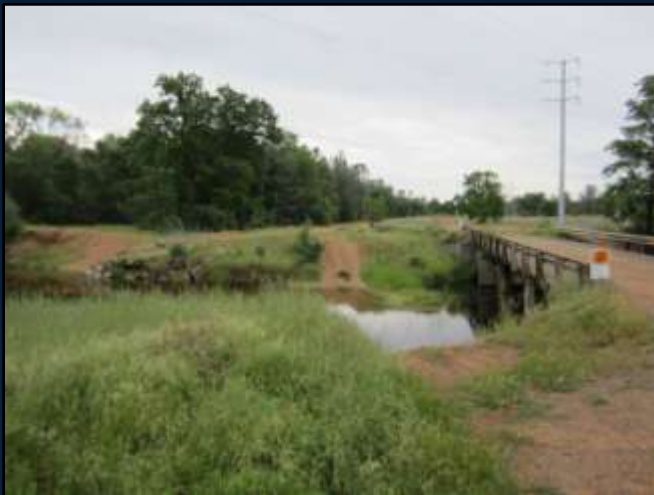
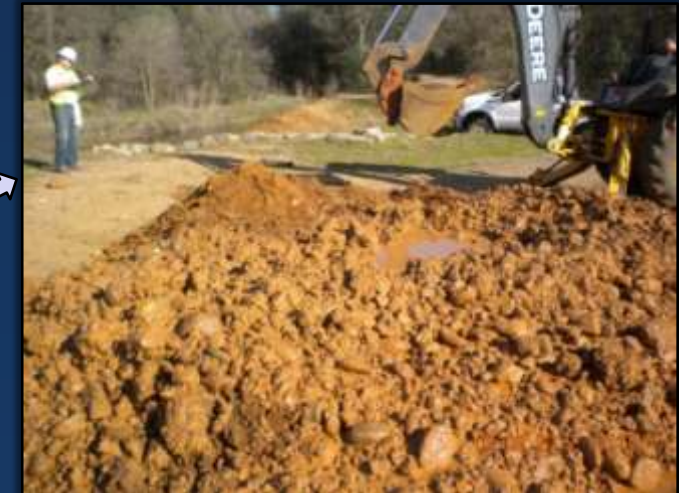
# Phase 4 – Investigation

- Pipe Bursting used to cross creeks – HDPE, DR 13.5, 11.80” pipe ID - no impact to pigging operation
  - Only required 1602 Streambed Alt Permit
- Excavated soil test pits for pipe bursting at creek crossings
- Limited pipe bursting to <260’ to avoid USEPA, Asbestos National Emission Standards for Hazardous Air Pollutants (NESHAP)

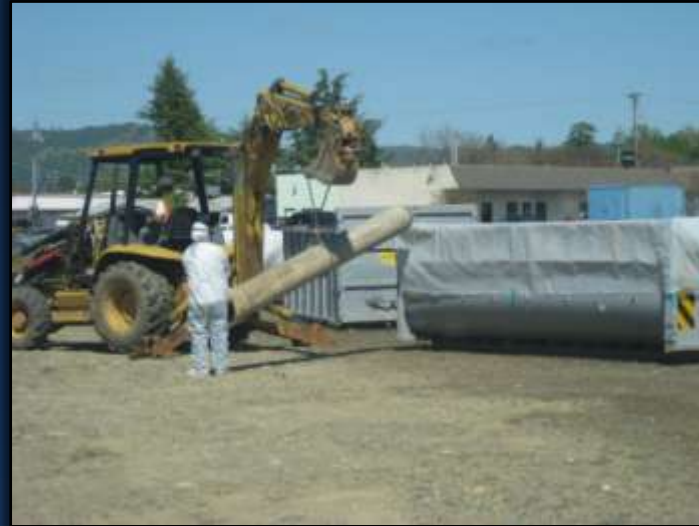
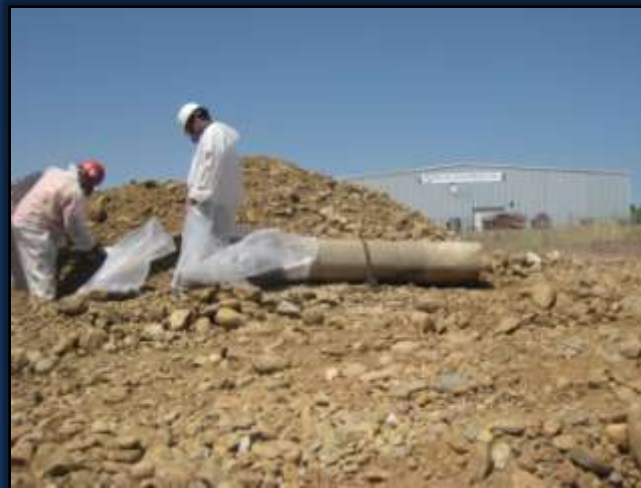
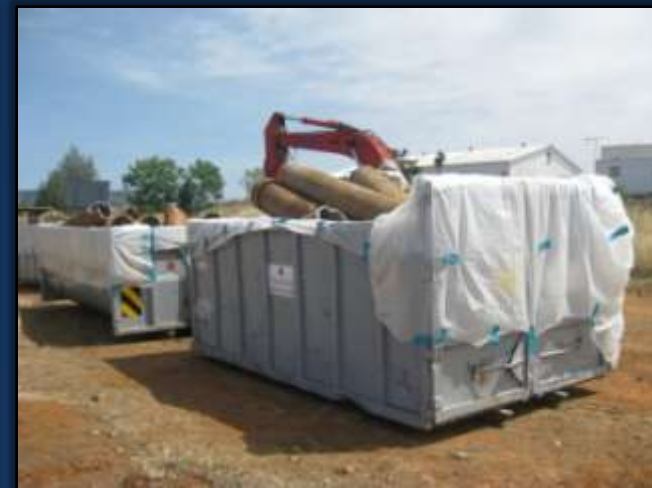
# Open Cut – Remove & Replace

### AC Pipe Removal and Replacement:

- Remove AC intact
- Bag AC pipe
- Dispose at landfill able to take AC pipe intact

### Abandon Casing for Parallel Construction:

- Fill pipe to avoid pipe/casing failure and road settlement
