*EAST BAY MUNICIPAL UTILITY DISTRICT*

# **Asbestos Cement Pipe Study**

## Phase 1 Asbestos Cement Pipe Corrosion Study

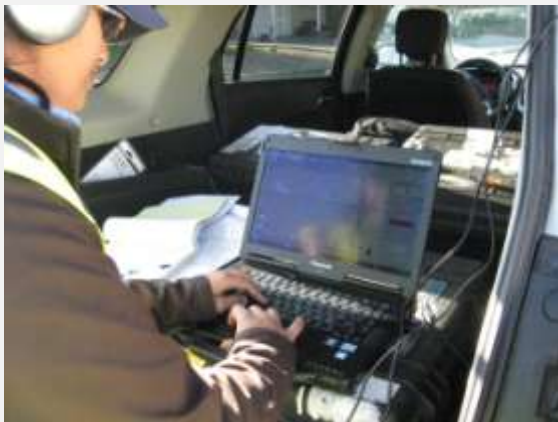
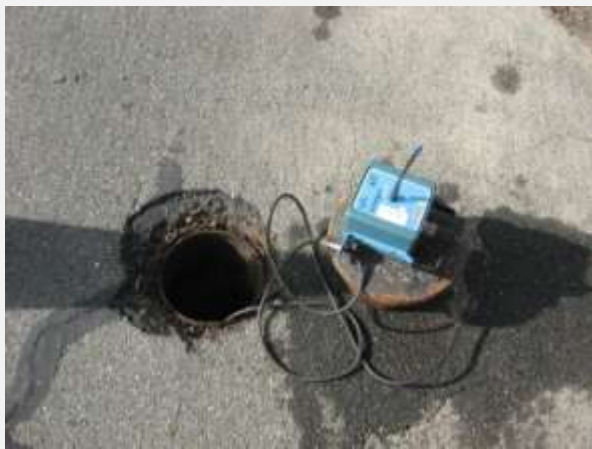
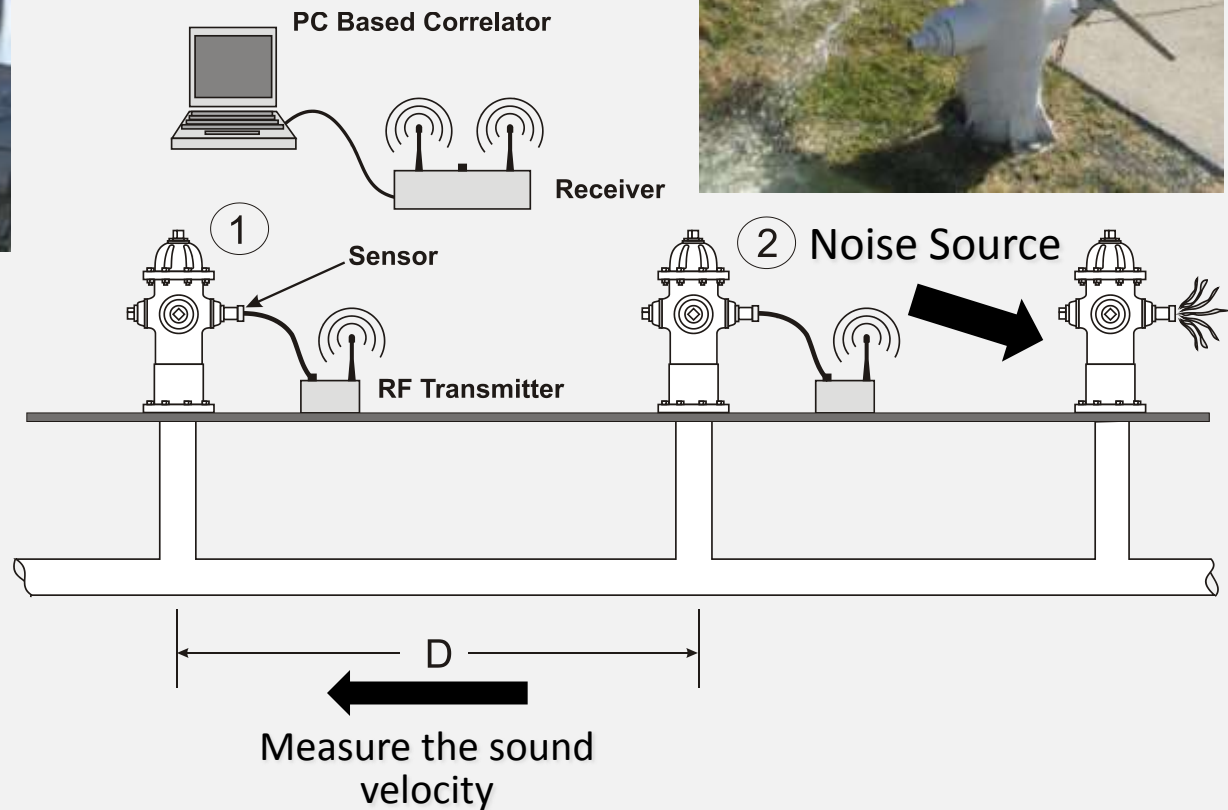
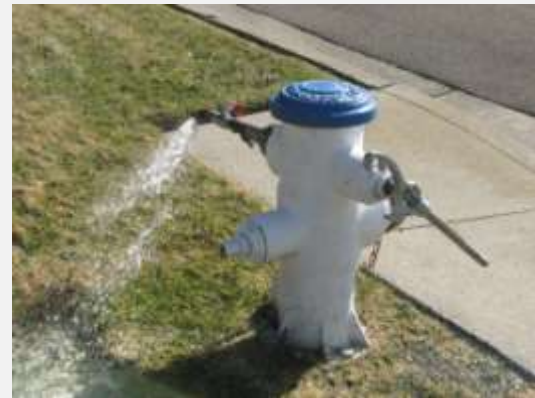
# Echologics Acoustic Surveys

Stain Test results compared to Echologics Surveys.

4 out of 6 pipe samples (non-break) have good correlation

4 out of 9 for coupons
